Analysis of the Pneumatic Burst of a Large Seamless Steel Pressure Vessel in Natural Gas Service

NBSIR 78-1589

Failure Analysis Report

December, 1978

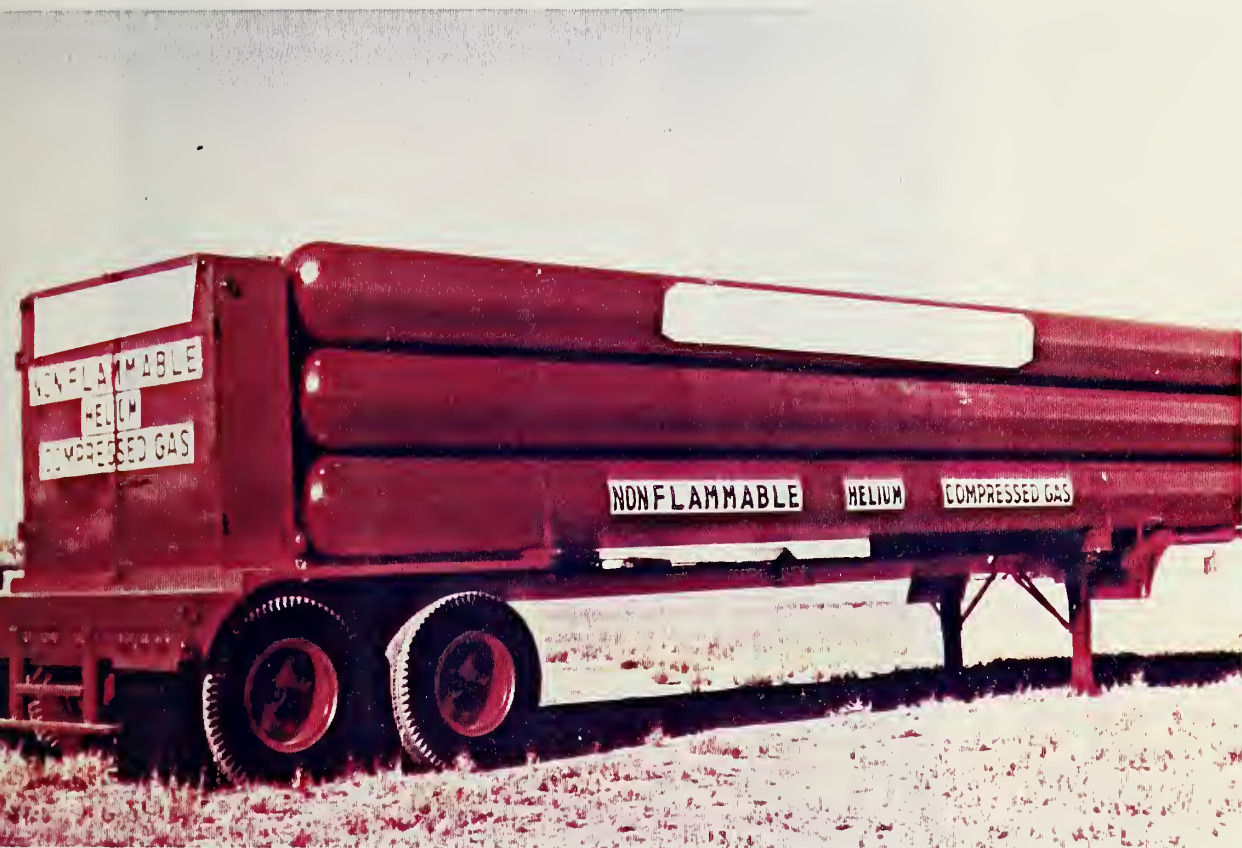
Figure 4. Intact tube trailer composed of specification DOT 3T cylinders. The array of cylinders on the trailer is 3-high by 4-wide. (Photo courtesy of Mr. W. Piehl, Western Sales and Testing, Inc., Amarillo, Texas.)

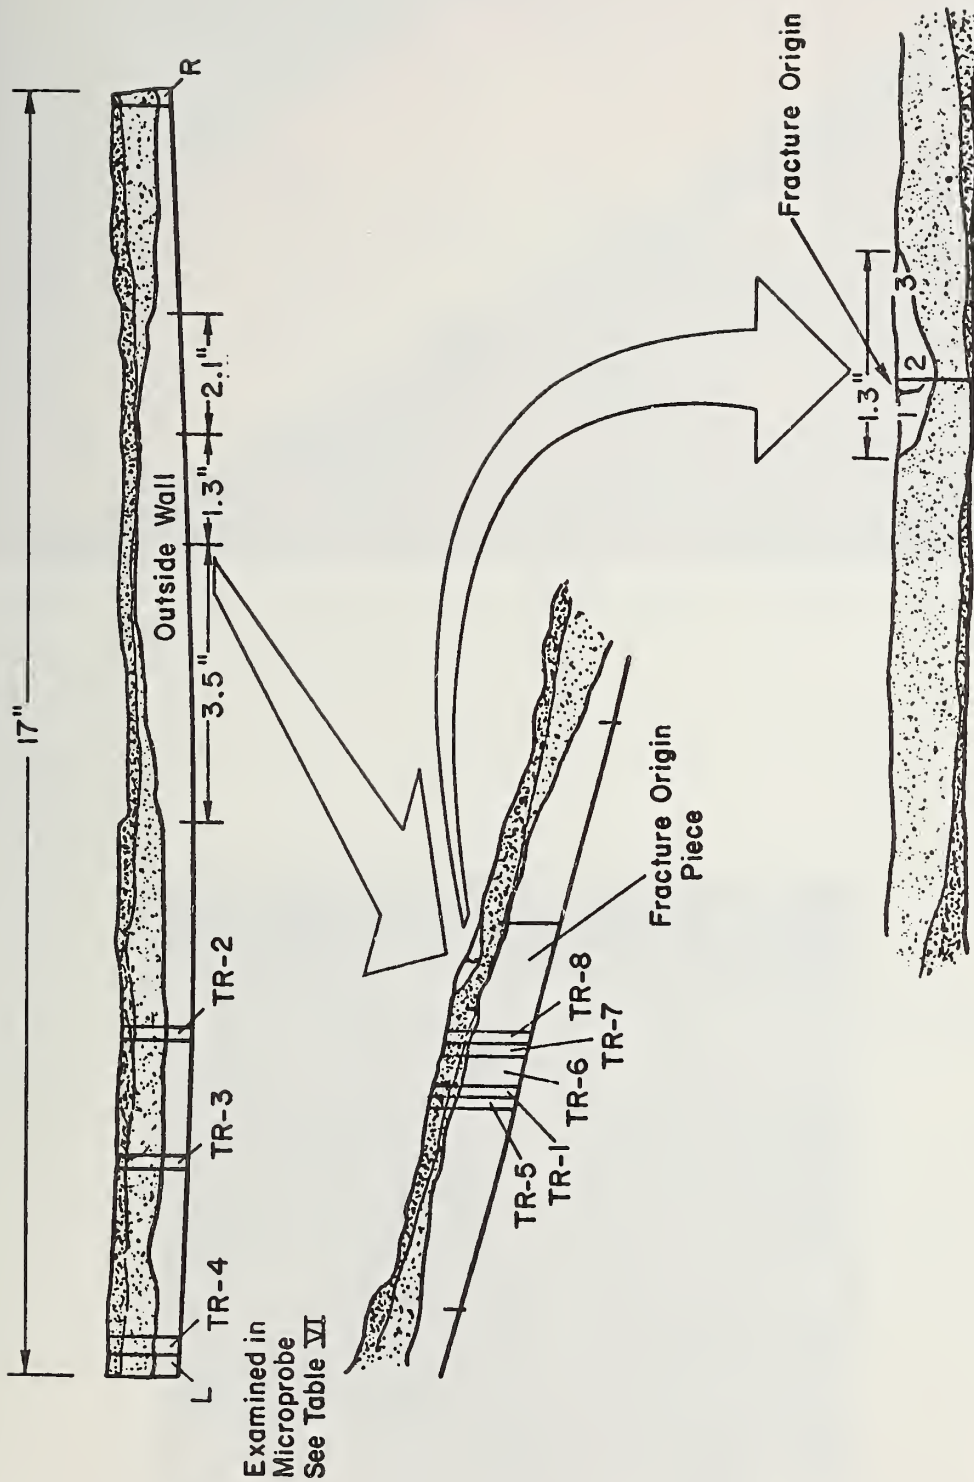
Electron microprobe analysis was carried out to characterize the microchemistry of the white-etching microzones. Specimen L in Figure 7c was selected for this examination. The microzone examined appears in Figure 13. Results are listed in Table VI. No carbon segregation was detected. Nor was sulfur segregation found. Phosphorus was the most intensely-segregated element, followed by chromium and molybdenum, and then manganese and silicon. Such microsegregation is probably typical in all the white-etching microzones.

tempering. A survey of microhardness was carried out in order to determine if the hardness of the white-etching microzones in which the Type C cracks occurred was different from the hardness of the surrounding material. Five transverse sections were examined. They are labeled TR-1, TR-2, TR-3, TR-5, and R in Figure 7c. Results appear in Table VII. The white-etching microzones were significantly harder than the surrounding material, as illustrated in Figure 3. Often, the Knoop microhardness measurements in the white-etching microzones converted to Rockwell-C scale hardnesses of 40 or greater. For comparison, the surrounding material was softer and exhibited equivalent hardnesses on the Rockwell C scale of 35 to 40.

Figure 7c. Artist's drawing of the segment containing the fracture origin. Transverse sections cut from this segment are labeled "TR-".

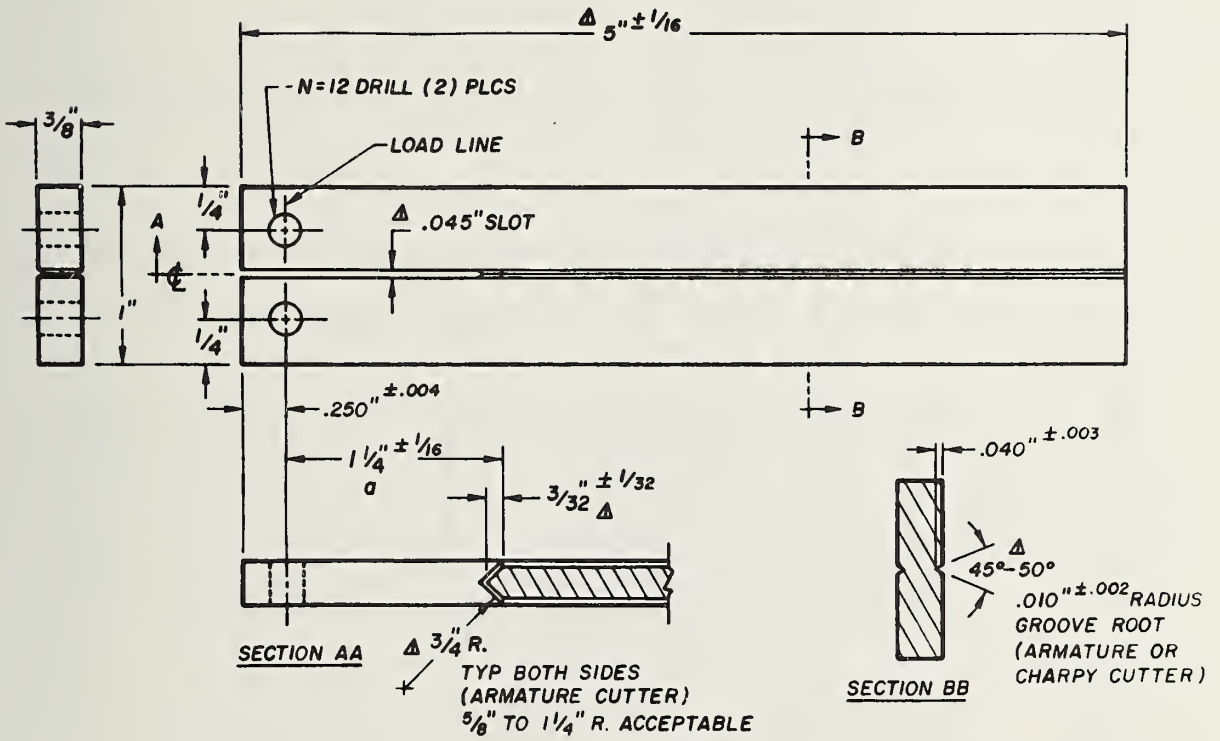
A wedge-loaded double cantilever beam test specimen was used, Fig. 26. Specimen thickness was 0.375-inches, which fulfills the requirement in ASTM E399-75^{15a} for a valid plane strain test for stress intensities up to 50 ksi $\sqrt{\text{in.}}$. The specimens were cut from the ring section such that the long axis of the specimen was parallel to the longitudinal axis of the cylinder. The axis of the crack was perpendicular to the wall thickness, so that the crack grew longitudinally. This orientation was selected to approximate the growth of the type L cracks discussed in Section 4.3.

Figure 26. Diagram of the double cantilever beam test specimen used for K_{ISCC} testing.

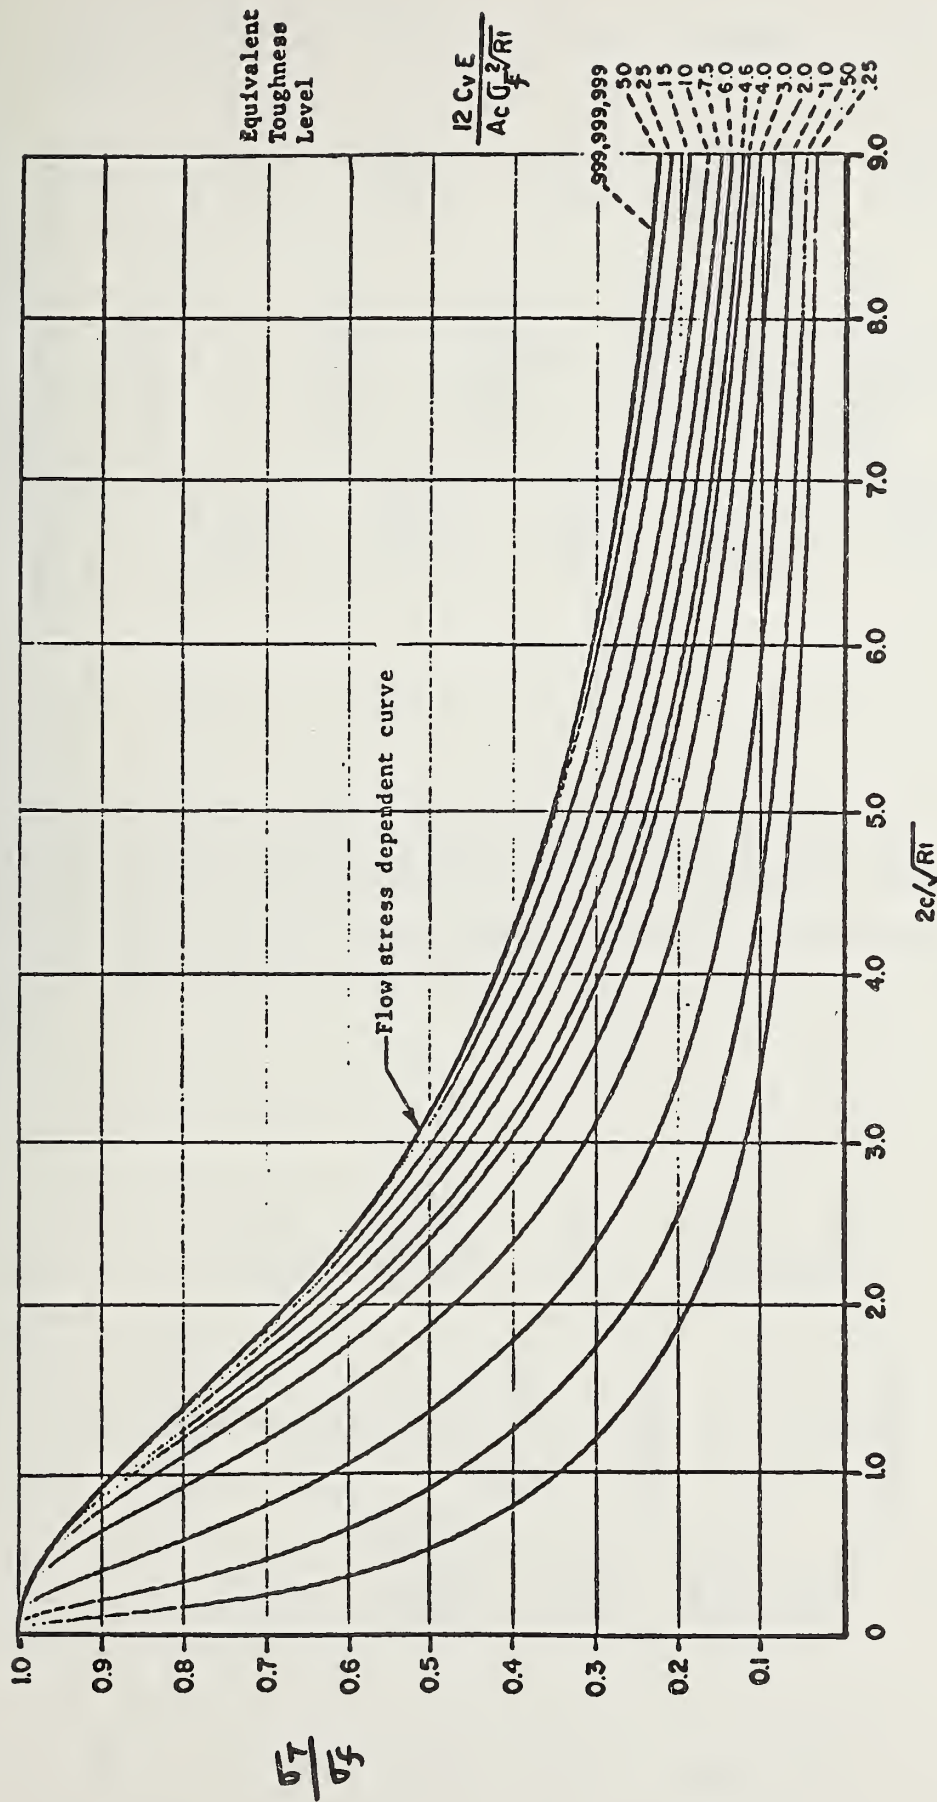
Figure 27. Through wall flaw size-toughness relationship for cylindrical pressure vessels.
(Diagram courtesy of W. Maxey of Battelle Memorial Institute, Columbus, Ohio.)
